CIRCUIT CHANGES

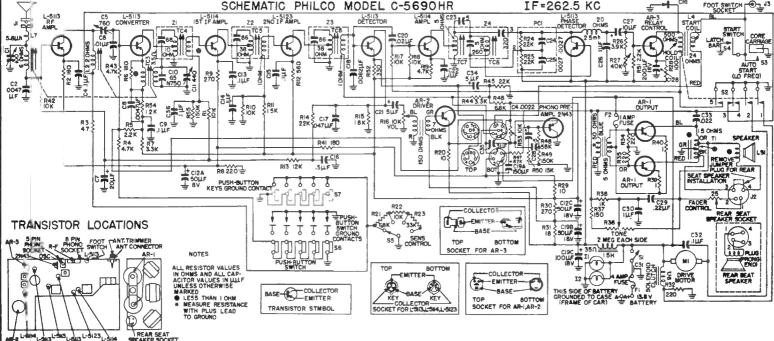
Resistor R55 was changed from 150,000 ohms to 220,000 ohms, part No. 66-4228340.

Resistor R45 was changed from 22,000 ohms to 82,000 ohms, part No. 66-3828340.

A 47-ohm, ½-watt resistor, part No. 66-0478340, was added between emitter detector transistor L-5113 and the junction of R52 C35 A .1-4fd capacitor, part No. 30-1260, was added between the emitter of Detector Transister L-5113 and ground.

Resistor R15, was changed from 1.8K to $2.7K \pm 10\%$, part No. 66-2278340.

Resistor R29 was changed from 10 ohm \pm 5% to 8.2 ohms \pm 5%, part No. 66-9823260.

Resistor R23 was changed from 33,000 ohms to 10,000 ohms, part No. 66-1038340.
