PHILCO TRANSISTOR RADIO

MODEL T-45 - CODE 124

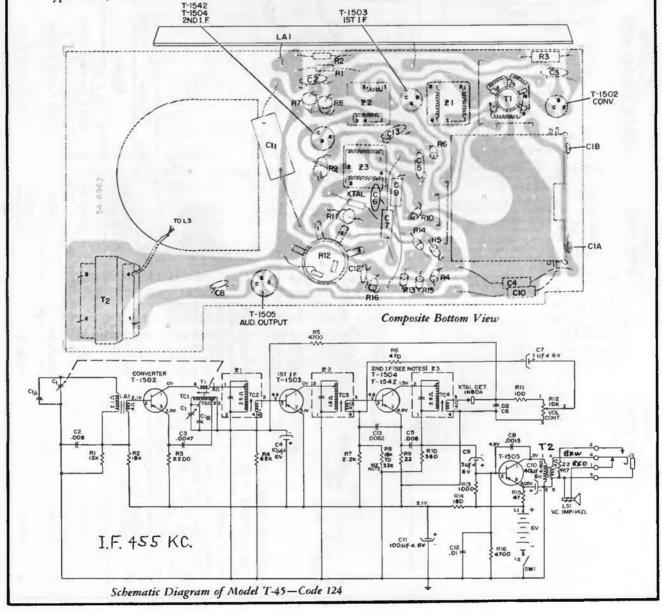
SCHEMATIC NOTES

CAUTION—Due to 2nd I-F transistor variations, the value of resistor R8 must be selected, within limits for optimum performance. When transistor T-1504 (or T-1542) is defective and must be replaced, resistor R8 must also be changed unless the original provides the proper resistor operating characteristics. Failure to select the proper resistor can shorten the life of the transistor or seriously affect receiver operation.

The value of R8 is selected to allow the 2nd I-F transistor collector to draw 2 milliamps and will be between 18,000 to 33,000 ohms. This is checked by measuring the voltage across R10, the 560-ohm collector return resistor. This voltage should be 1,12 volts, with a 10% tolerance (±.12 volt).

All resistors are ½ watt, 10%, carbon, except R8 which is 5%. Coil resistances read with coil in circuit. Voice coil impedance = 14 ohms. Voltages measured to ground with a 20,000 ohms/volt meter under no signal conditions.
