# RCA VICTOR

Battery-Operated Pocket Radio

## MODEL 9-BT-9 Series

Chassis No. RC-1164A, RC-1164B

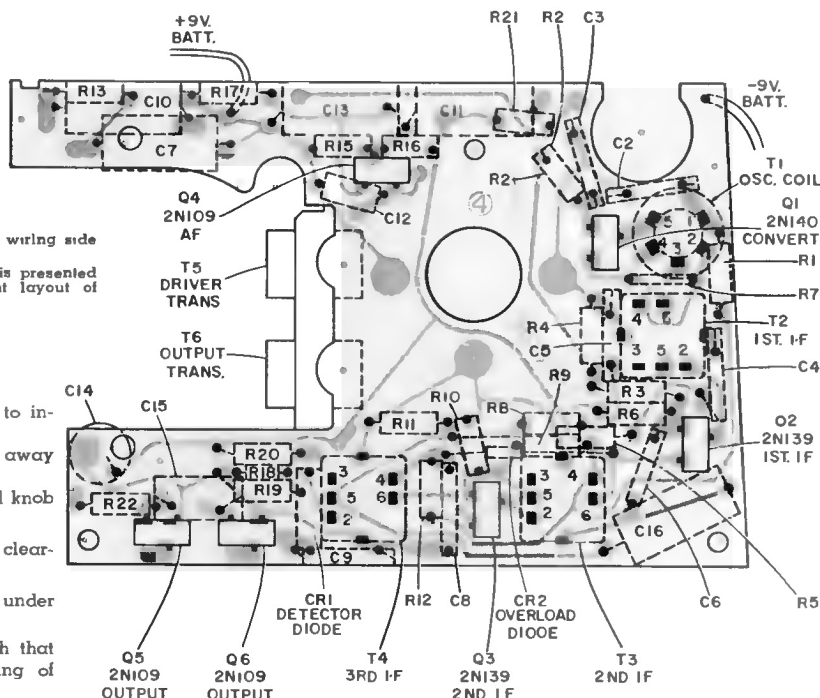
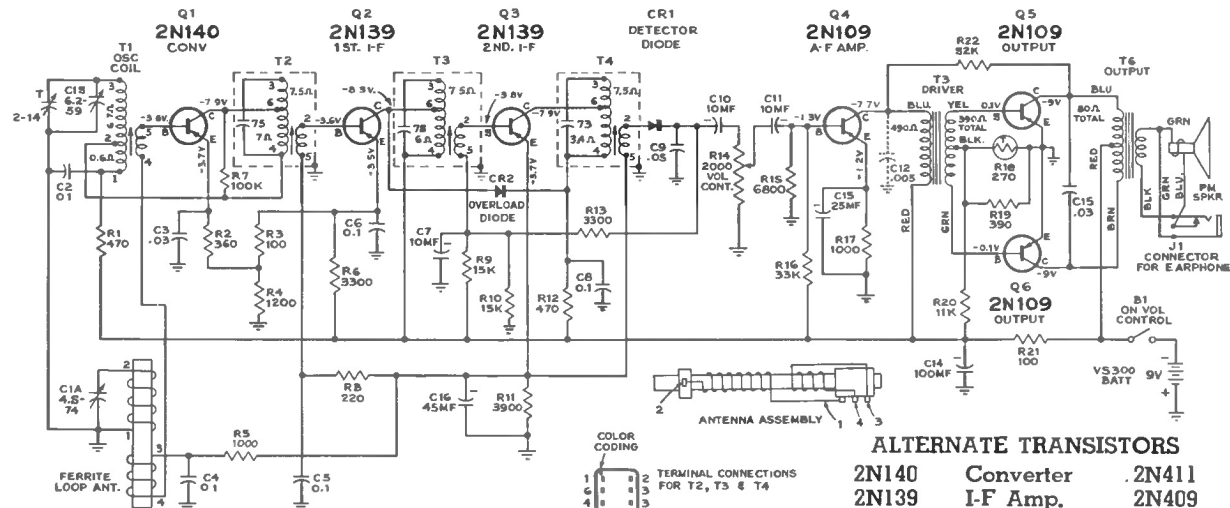
Printed Circuit Board Wiring and Components  
View from Wiring Side

Circuit Board No. 961919-1  
Chassis No. RC-1164A

The assembly represented above is viewed from the wiring side of the board.

The printed wiring, on the near side of the board, is presented in "phantom" view superimposed on the component layout of the reverse side.
