Schematic Diagram of Model T-78

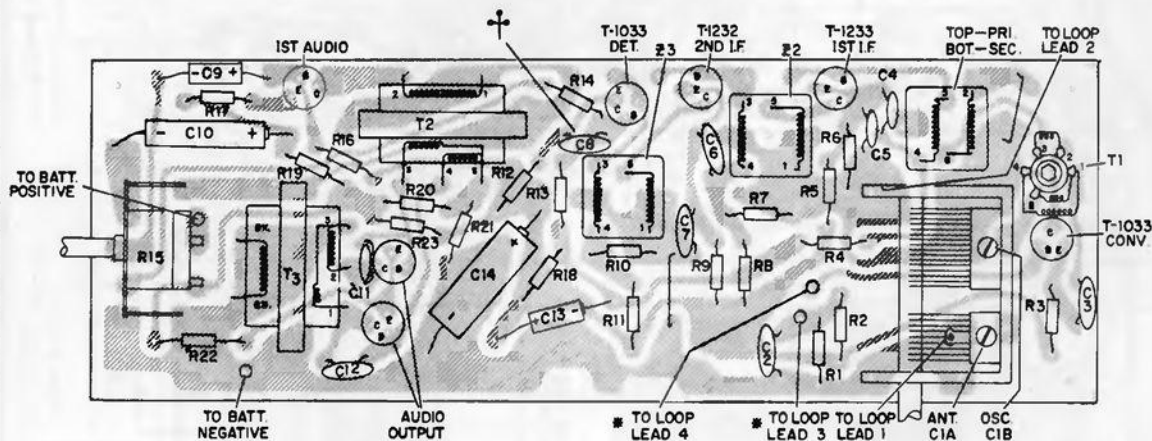
Top View, PW Panel

\* LOOP LEADS 3 & 4—DRESS BETWEEN EDGE OF PRINTED PANEL AND MASONITE FRONT PLATE. CONNECT TO TIE LUGS INDICATED ON FOIL SIDE OF PANEL.

The dress (position) of condenser C8 may be helpful in reducing harmonic whistle when encountered. C8 may be bent over toward R14 and the detector transistor. In sets where C8 is in this bent position, do not disturb.
