RCA VICTOR

MODELS 3-HES-5, 3-HES-5A

Chassis No. RS-146, RS-146X

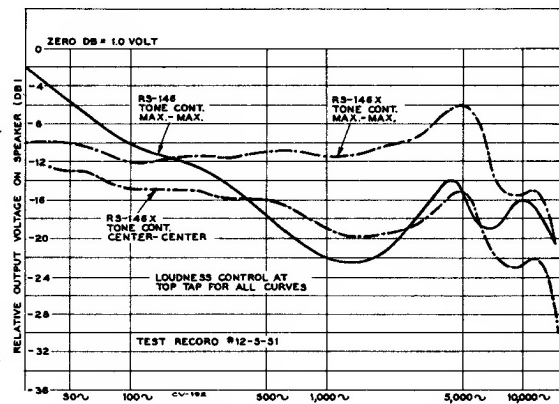
Overall Frequency Response using Test Record
