RCA Victor T-2 Series, Chassis RC-1189A.  
T-1 Series, Chassis RC-1189, and PT-1  
Series, Chassis RC-1189B, are practi-  
cally the same.

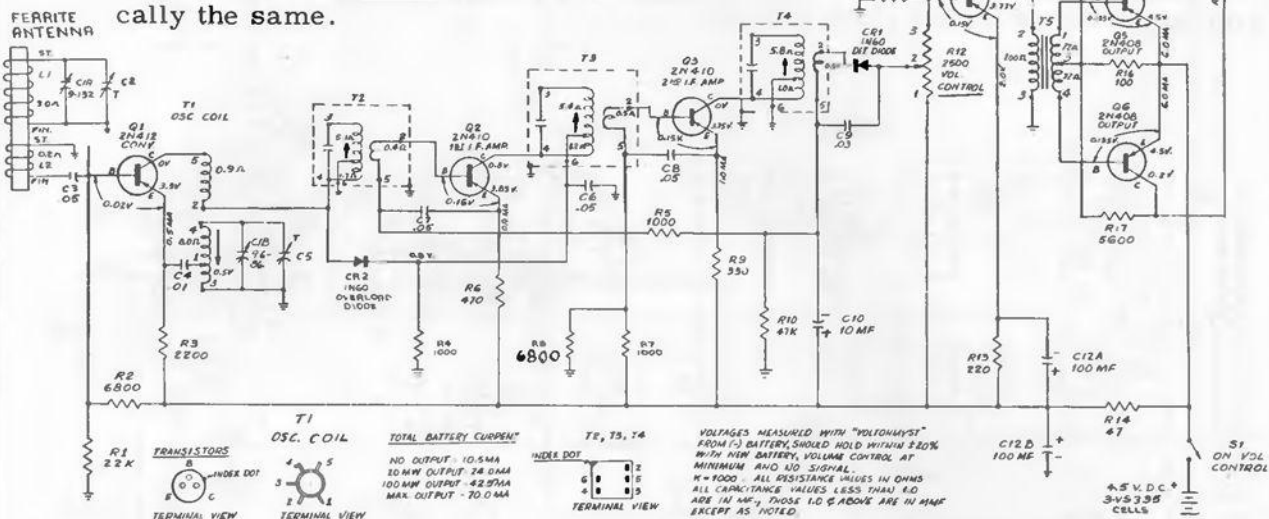
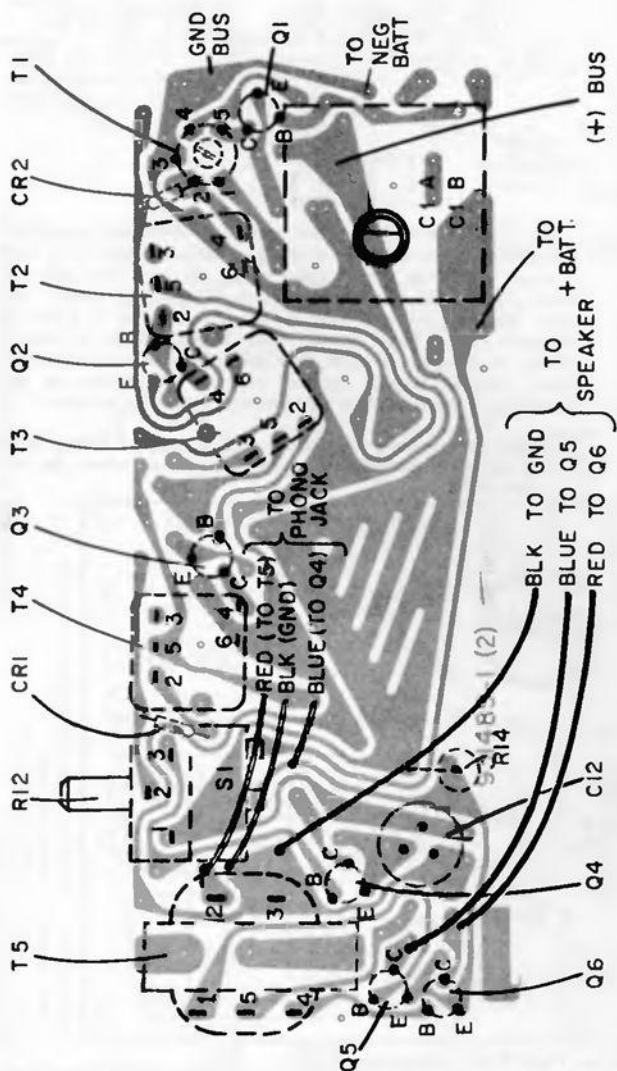
Chassis Wiring and Components — View from Wiring Side

Damage can result from trying to pull or pry the tuning knob off from the front. To remove—remove the three chassis mounting screws, grasp the tuning capacitor and pull it out of the knob.
